TESTING REPORT

Customer	: M. Almasar Adhila Putro	Total of Page	: 1 of 3
Object to be Tested	: Plate	Date of Tested	: 26-Aug-22
Location of Performance	: PT Detech Profesional Indonesia	Sample Marking	: Plate Al 1.5 mm Thickness

Environment Temp	: 25 ± 2 °C	Reference Code	: -
Type of Test	: Vickers Hardness Number (HV) Load Test, 5 Kgf		
Test Method	: ASTM E92-17

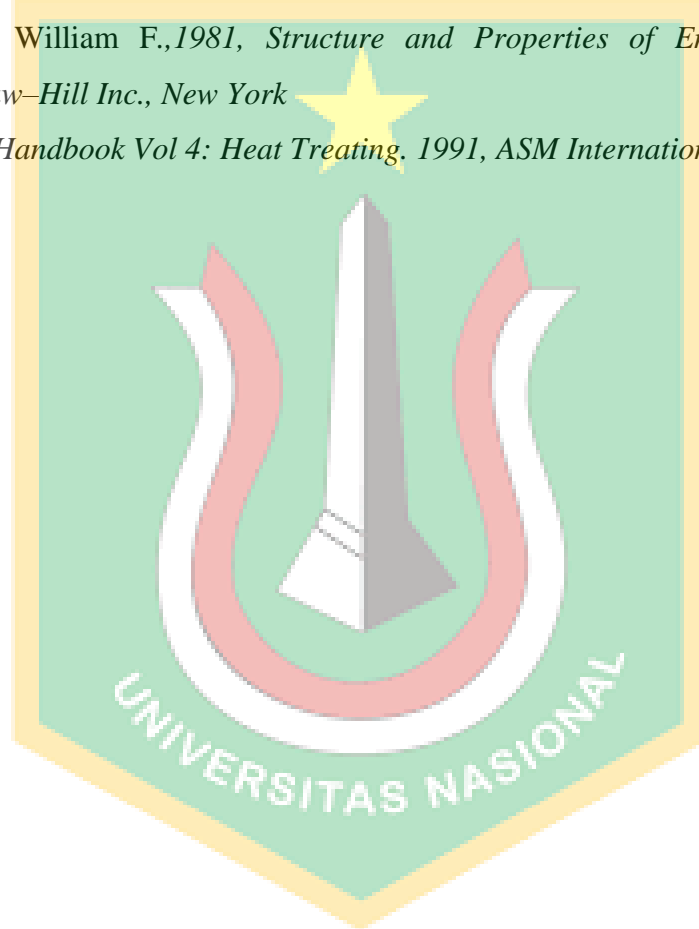
Vickers Hardness Number (HV), Test Load Applied, 5 Kgf						
Material Specification	Aluminium 2024					
Location	Base Metal					
	1	2	3	4	5	Average
Result	48.8	49.2	47.9	48.3	48.8	48.7

Testing Machine Used	: Vickers Hardness Tester, Model : MHRVS-50AT, S/N : 17043
Remarks	: -
Test Conducted by	: Alfa Sendya Hayu Marzuki, S.T

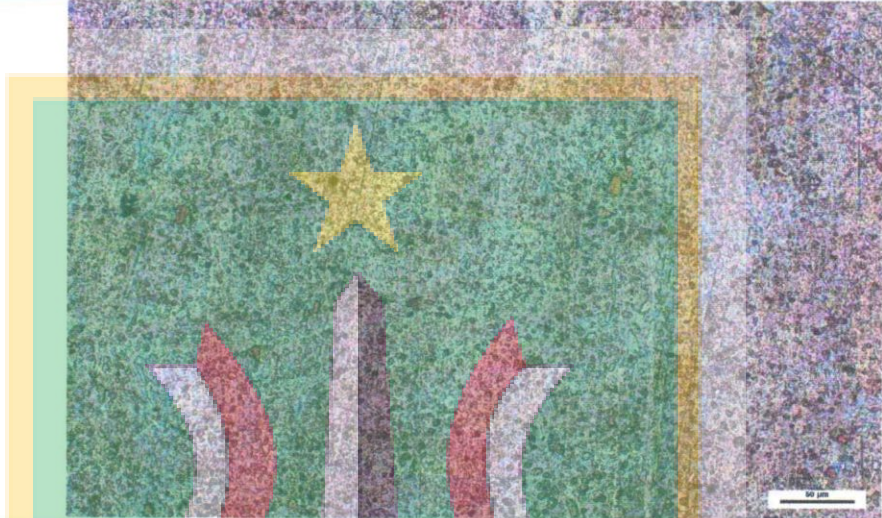
Sample Identification	Microstructure Photograph
200X

Environment Temp : 25 ± 2 °C
Type of Test : Metallography Examination
Test Method : ASTM E407 - 07

Testing Machine Used : Nikon MA-100 Optical Microscope
Remarks : Etch with solution of 3 mL HF + 100 mL Water

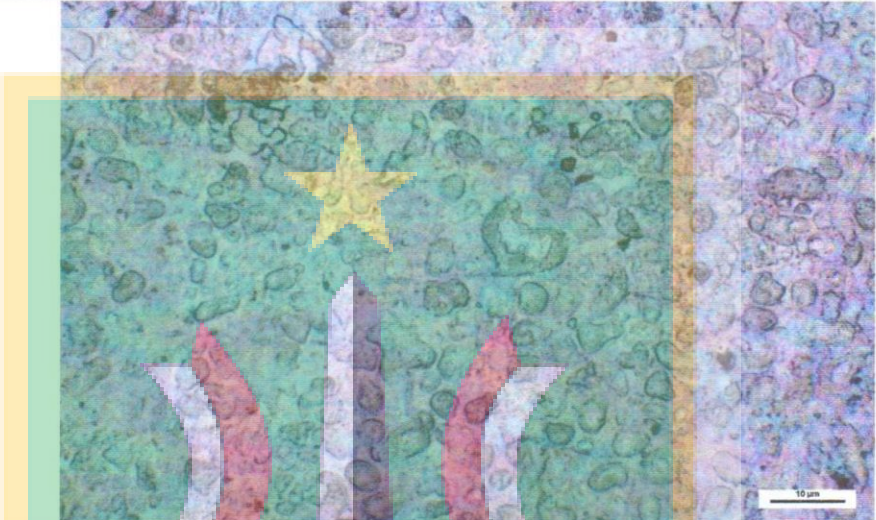
Sample Identification	Microstructure Photograph
1000X

Environment Temp : 25 ± 2 °C
Type of Test : Metallography Examination
Test Method : ASTM E407 - 07

Testing Machine Used : Nikon MA-100 Optical Microscope
Remarks : Etch with solution of 3 mL HF + 100 mL Water

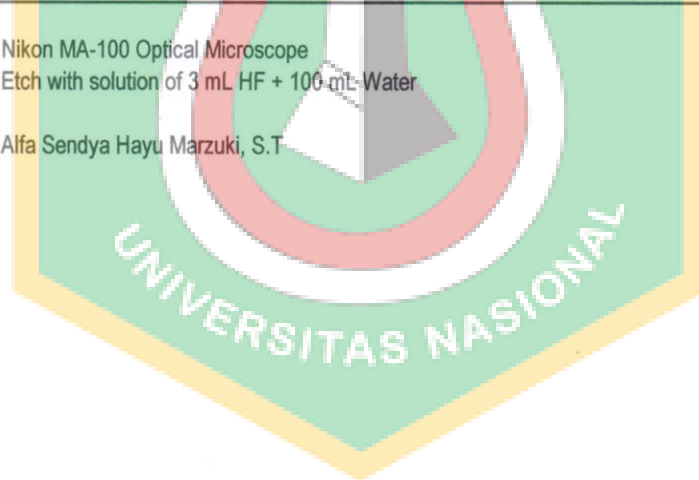
Environment Temp	: 25 ± 2 °C	Reference Code	: -
Type of Test	: Vickers Hardness Number (HV) Load Test, 10 Kgf		
Test Method	: ASTM E92-17

Vickers Hardness Number (HV), Test Load Applied, 10 Kgf						
Material Specification	Aluminium 2024					
Location	Base Metal					
Result	1	2	3	4	5	Average
	141	140	141	142	143	141.4

Testing Machine Used	: Vickers Hardness Tester, Model : MHRVS-50AT, S/N : 17043
Remarks	: -
Test Conducted by	: Alfa Sendya Hayu Marzuki, S.T

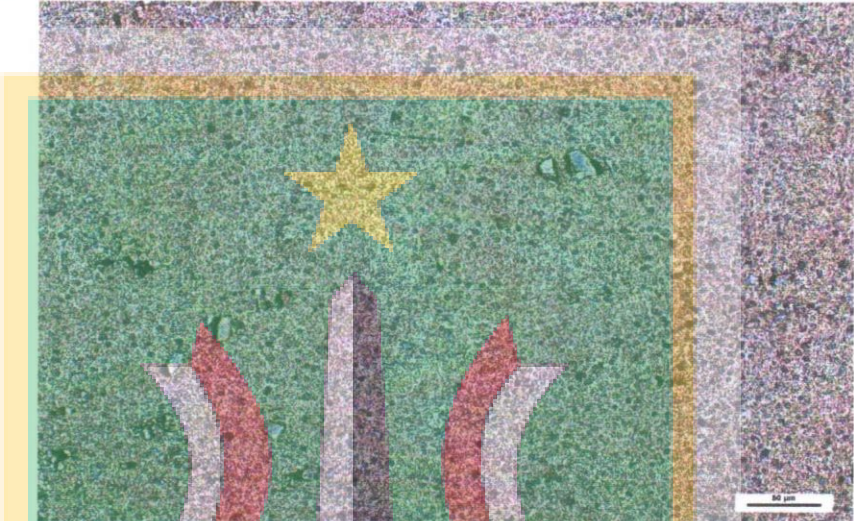
Sample Identification	Microstructure Photograph
200X

Environment Temp : 25 ± 2 °C
Type of Test : Metallography Examination
Test Method : ASTM E407 - 07

Testing Machine Used : Nikon MA-100 Optical Microscope
Remarks : Etch with solution of 3 mL HF + 100 mL Water

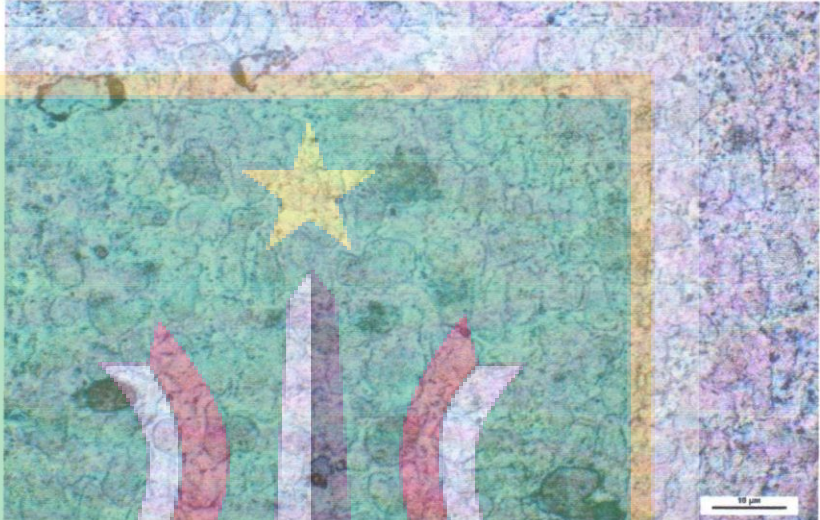
Sample Identification	Microstructure Photograph
1000X

Environment Temp : 25 ± 2 °C
Type of Test : Metallography Examination
Test Method : ASTM E407 - 07

Testing Machine Used : Nikon MA-100 Optical Microscope
Remarks : Etch with solution of 3 mL HF + 100 mL Water

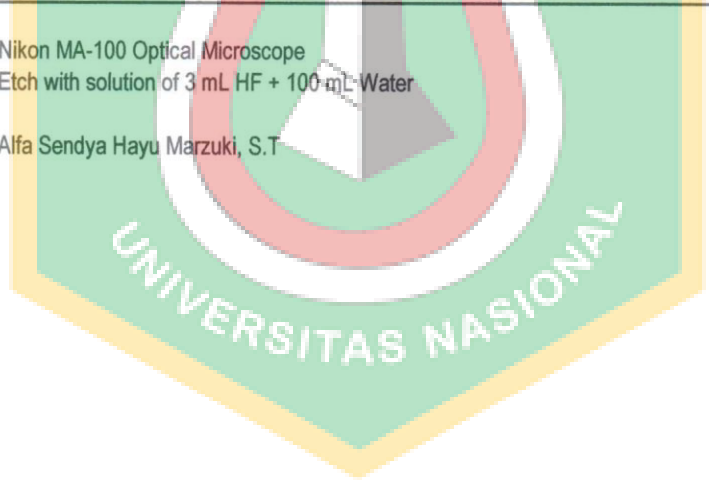
*****
AUG: 48.7
MIN: 47.9
MAX: 49.2
001 48.8 HV5
D1=435.8 D2=435.8
002 49.2 HV5
D1=434.0 D2=434.0
003 47.9 HV5
D1=439.9 D2=439.5
004 48.3 HV5
D1=438.1 D2=437.7
005 48.8 HV5
D1=437.4 D2=433.9
*****
*****
AUG: 142.1
MIN: 140.0
MAX: 143.0
001 143.0 HV10
D1=358.6 D2=361.4
002 142.0 HV10
D1=361.4 D2=360.7
003 141.0 HV10
D1=362.4 D2=363.8
004 140.0 HV10
D1=363.1 D2=364.0
005 141.0 HV10
D1=361.0 D2=363.9
*****
